Portage Creek Sediment Remediation Project Kalamazoo, Michigan

Pre-Sediment Removal Structure Feature Assessment Removal Areas SA5-A and SA5-B

F&V Project Number: 809930 August, 2012

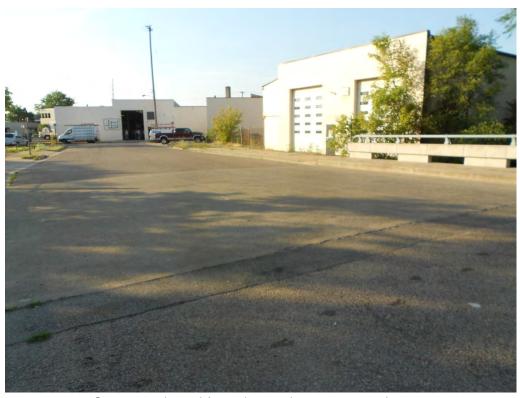
Structure viewed from the northwest approach area

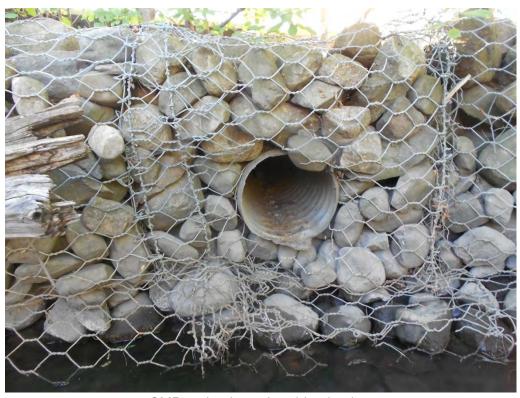
CMP outlet through gabion basket

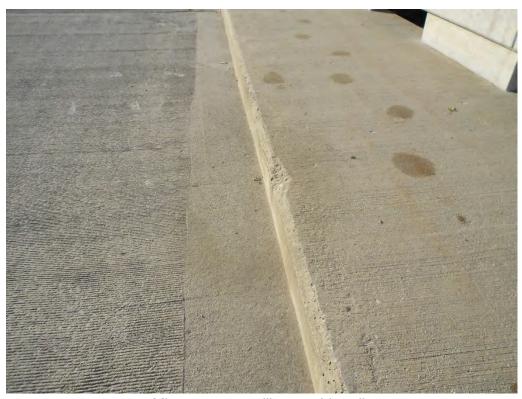
Minor corner spalling on sidewalk

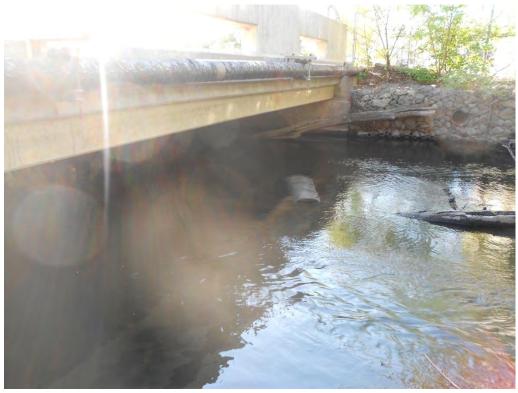
Trash and treefall in channel area

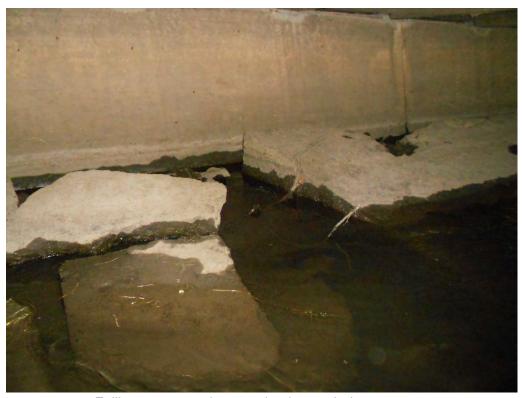
Failing concrete slope paving beneath the structure

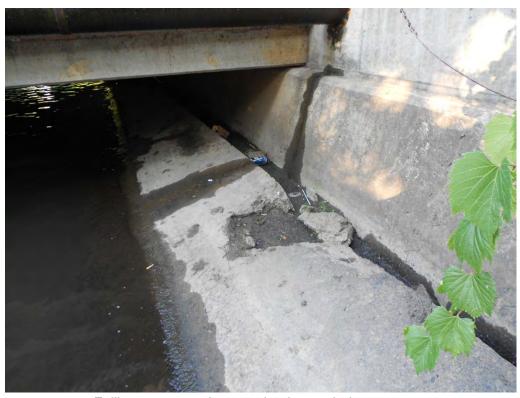
Failing concrete slope paving beneath the structure

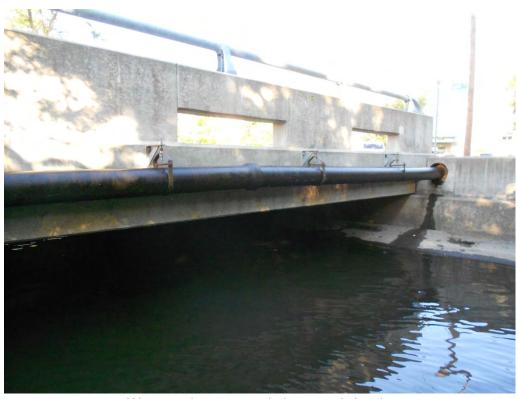
Water main supported along north fascia

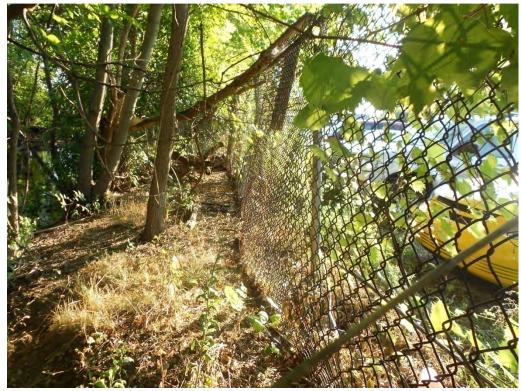
• Several sections of fence are failed or failing.

Failing section of fencing

• Remove and replace fencing in kind as required.

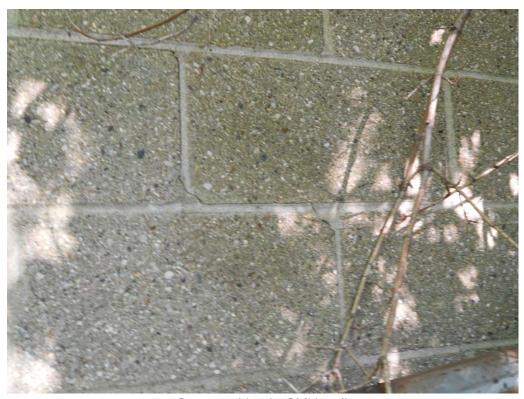
Minor to moderate step cracking was noted in exposed areas of CMU walls.

Step cracking in CMU wall

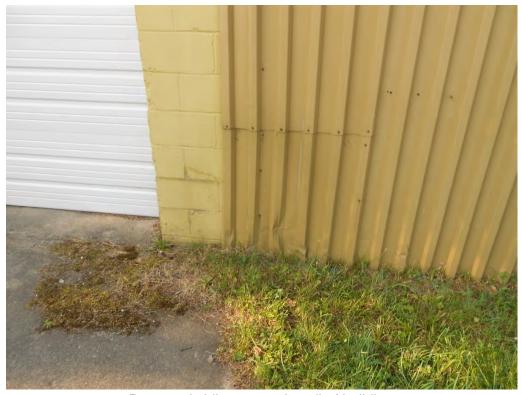
Damaged siding on north wall of building

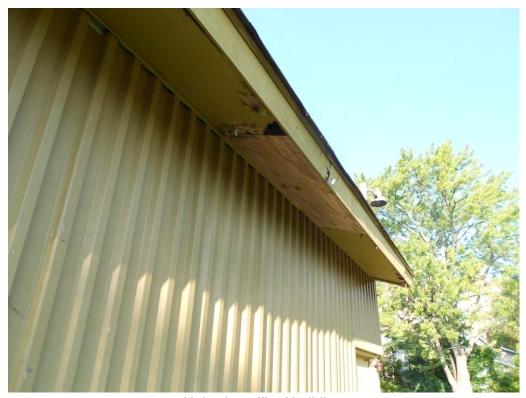
Holes in soffit of building

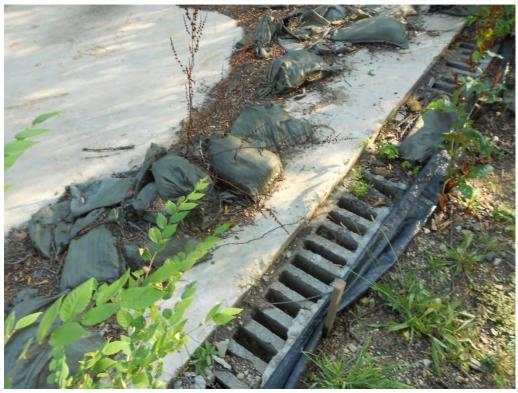
The concrete slab has moderate cracking throughout.

Cracking in concrete slab

- Based on the cracking exhibited by the slab, it is likely not sufficient for construction traffic
 and should be avoided during the work, protected with construction fencing or similar. If it
 cannot be avoided, areas damaged during construction should be removed and replaced in
 kind.
- The edge of slab appears to be sufficiently removed from the channel such that it will not be impacted by sediment removal.

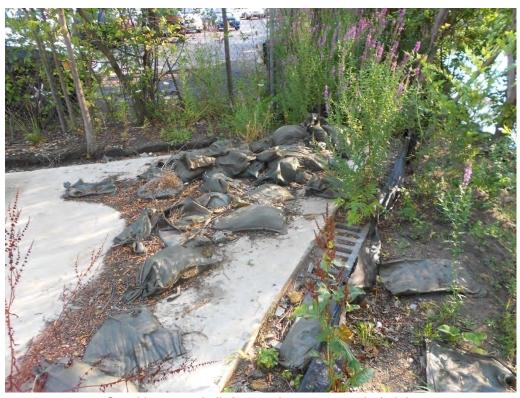
• There is a row of deteriorated sand bags along the edge of the slab and failed silt fence beyond.

Sand bags and silt fence along east end of slab

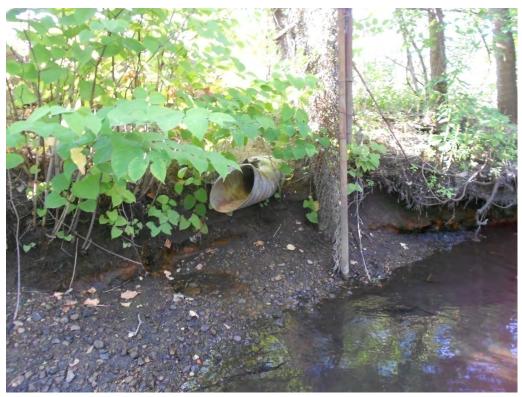
The pipe has moderate corrosion. It is crushed and failed.

• The bank around the outlet has moderate to severe undercutting.

View of outlet from channel

• Based on the apparent minor plunge pool, it appears that the outlet still carries a small amount of water. Therefore, cutting off the damaged and undercut portion of the pipe is recommended to accommodate sediment removal.

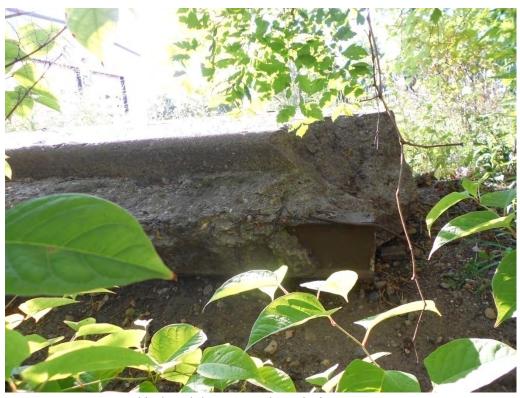
• The concrete is severely undermined at the north end and moderately undermined elsewhere.

Undermining at south end of concrete

It is recommended that the property owner be contacted to determine whether the structure can be removed and either eliminated or replaced in kind to facilitate sediment removal operations.

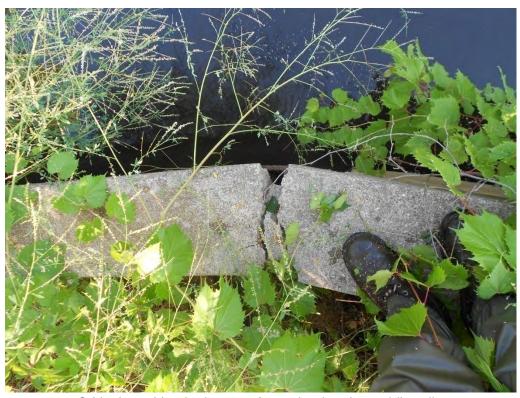
- There is significant erosion and cracking at the south end of the wall.
- The wall leans significantly toward the channel.
- There is significant vegetative growth through the joint above the waterline.
- Moderate surface corrosion was noted on steel piles.
- The second pile from the south leans approximately 20 degrees. The second panel from the south is failing with an exposed and broken strand at the north end. The south panel is partially failed. The third panel from the south to the north end is in fair condition.
- The wall is overgrown.

Critical cracking in the top of panel at leaning soldier pile

- Because of the severe condition of the south end of the wall and unknown depth of concrete panels, it is recommended that a minimum 6' clearance be maintained during sediment excavation.
- It may be effective to construct a cofferdam parallel to the wall and brace the existing wall during sediment removal, especially if equipment is to be placed behind the wall during the work.

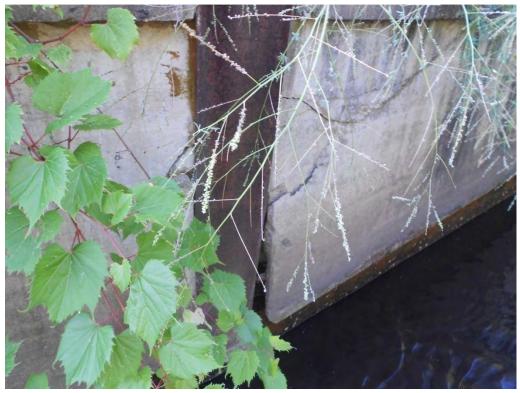
Severe to critical spalling of concrete panel at solder pile

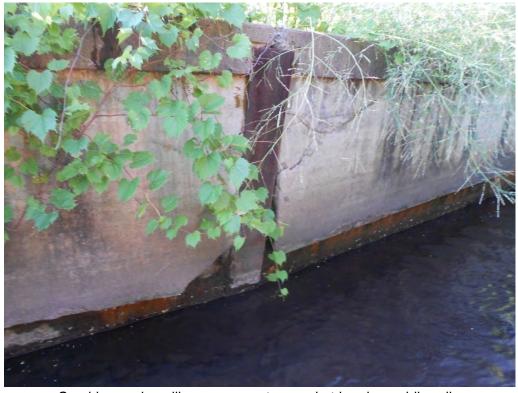
Cracking and spalling on concrete panel at leaning soldier pile

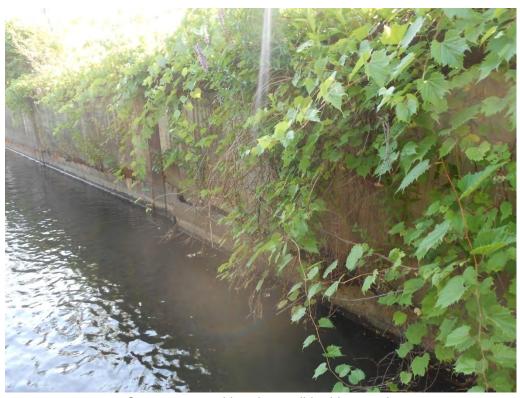
Overgrown and leaning wall looking north

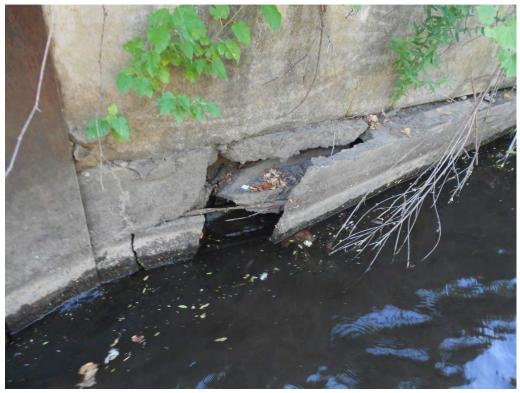
Severe spalling of panel at waterline with failed strand

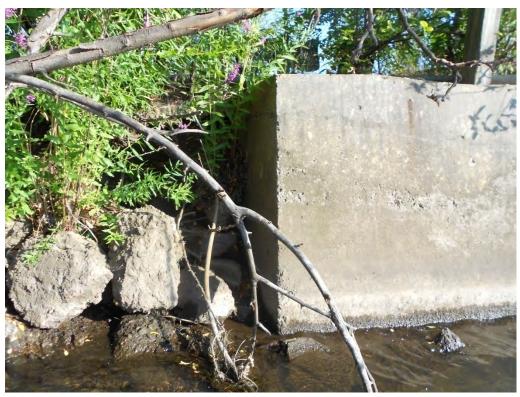
- There is moderate bank erosion around the south end of the wall.
- There is a moderate to severe vertical crack in the center of the wall.
- An abandoned timber guardrail post remains at the top of the south area of the wall.
- The top of wall has a concrete curb with small circular penetrations and scattered moderate vertical cracking.
- The wall has hairline map cracking and popouts throughout.

Erosion around south end of wall

• It is recommended that a minimum 4' clearance be maintained during sediment excavation.

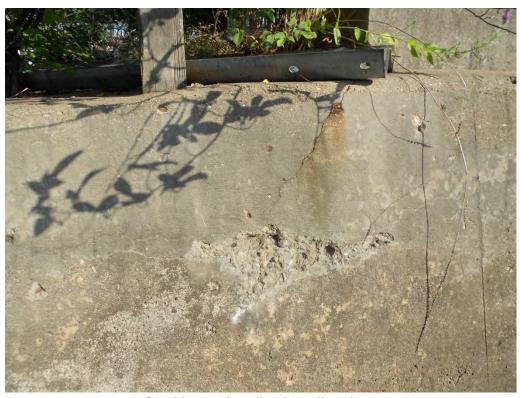
Cracking and scaling in wall surface

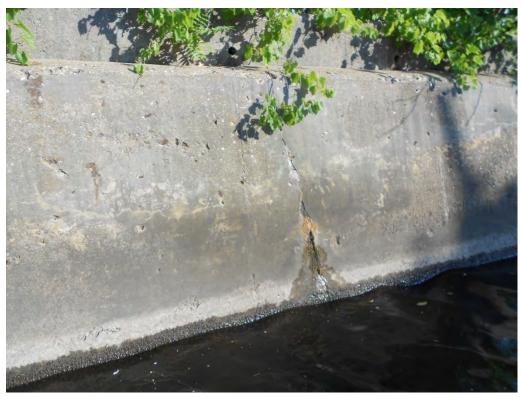
Vertical crack in center of wall

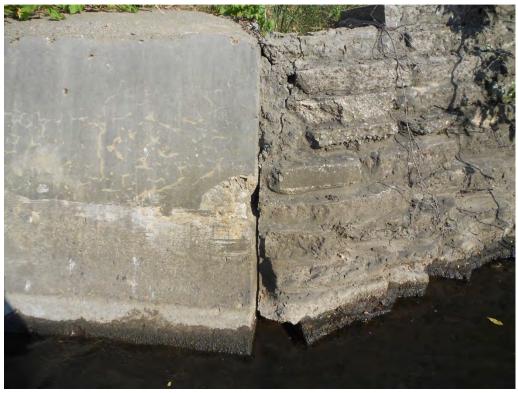
Joint between concrete wall and block wall of bridge

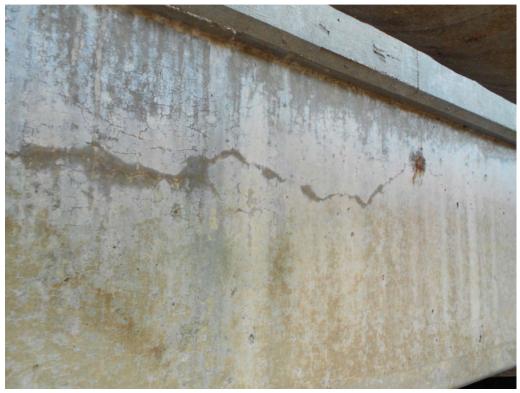
- There is a gas main supported along the south fascia and water main along the north.
- Hairline horizontal/map cracking was noted in the box beam fascias. Efflorescence and stalactites were noted along several box beam joints.

Hairline horizontal cracking in box beam fascia

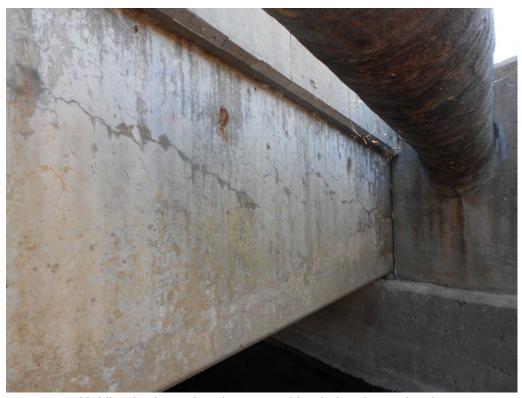
Hairline horizontal and map cracking in box beam fascia

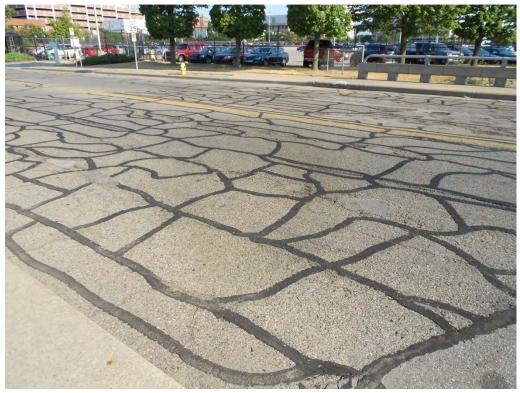
- There is a concrete outlet through the face of the abutment.
- The asphalt wearing surface has severe cracking and spalling, which is partially sealed and cold patched.

Sealed cracking and spalling in asphalt surface

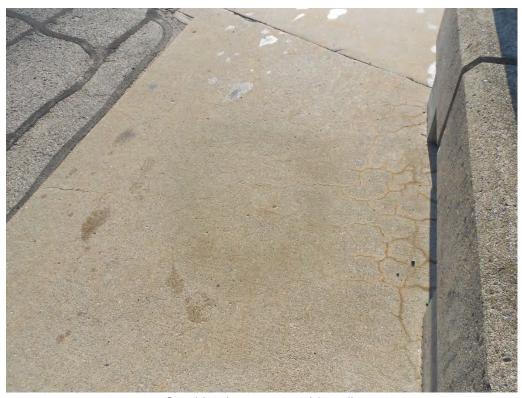
- The concrete sidewalk has hairline map cracking. Approach sidewalk has settled ~1-1.5" at the structure. Severe map cracking with shallow spalling was noted in the northwest sidewalk and moderate longitudinal cracking in the north sidewalk.

Cracking in concrete sidewalk

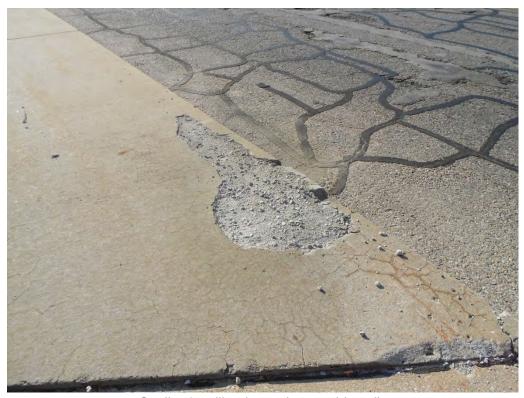
Scaling/spalling in northwest sidewalk

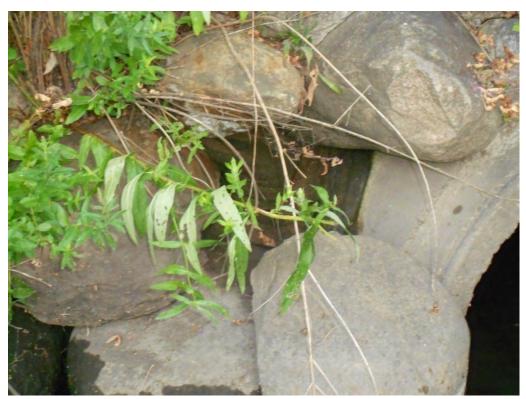
• Stone riprap around the outlet has settled into the channel, exposing geotextile fabric in several areas.

Exposed geotextile fabric from failed riprap

• We understand that sediment removal is not planned in area SA5-B. However, if plans change, the outlet should be isolated with a cofferdam to allow for dewatering. The cofferdam should be installed with a minimum 2' clearance to the outlet.

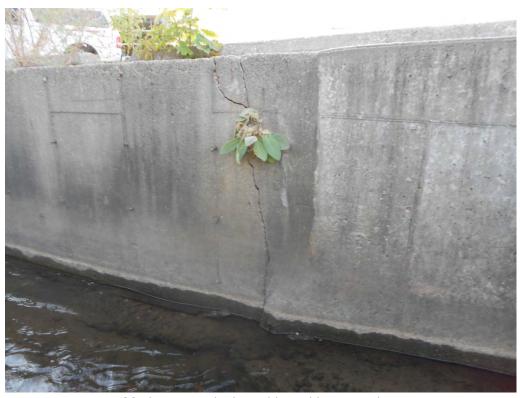
Moderate vertical cracking with vegetation

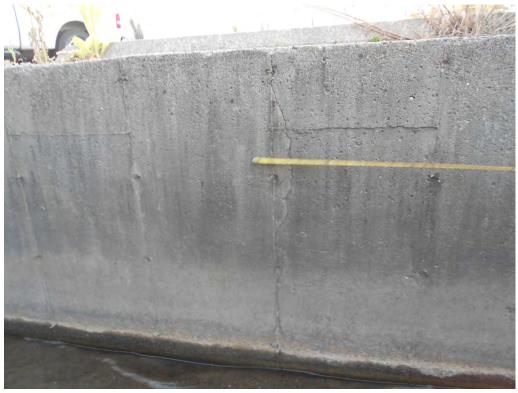
Vertical cracking in the concrete wall

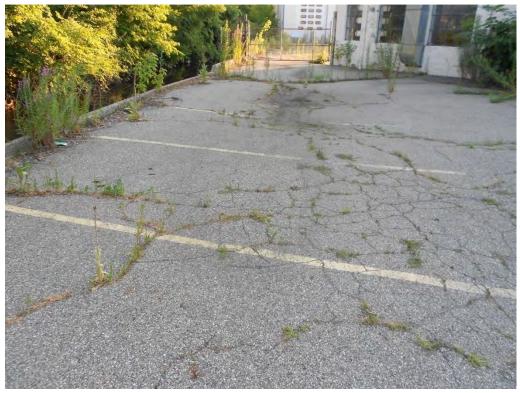
- Form ties are exposed and corroded along the face of wall.
- Moderate vertical cracking was noted 9' and 12' north of the south end of wall.
- The asphalt parking lot has moderate to severe cracking throughout with vegetation growth through the cracks.

Cracking with vegetation in the asphalt parking area

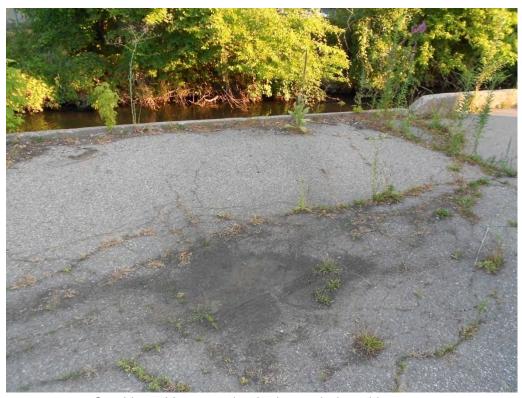
Cracking with vegetation in the asphalt parking area

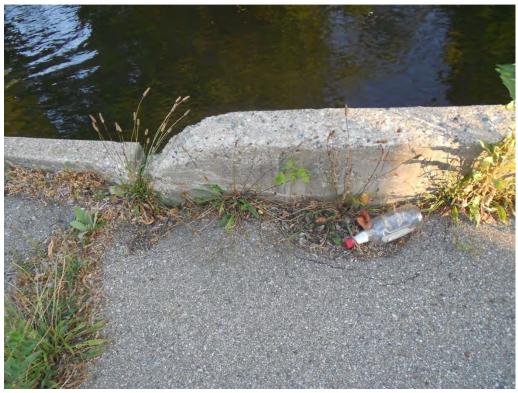
Settlement of asphalt pavement along retaining wall at cold joint

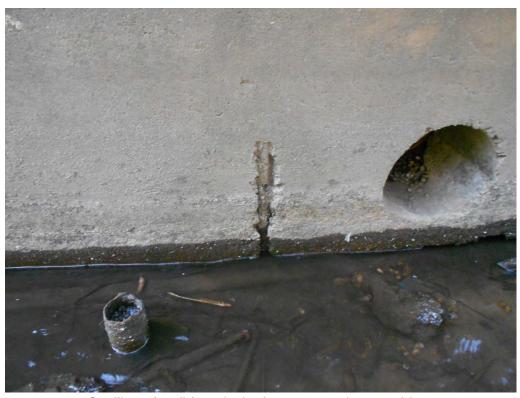
Spalling of wall from lack of cover on unknown object

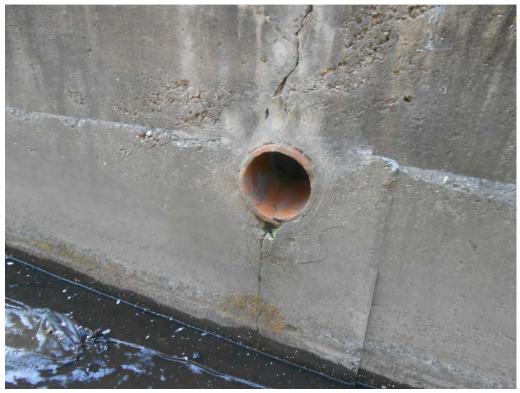
Clay tile outlet through wall with vertical cracking

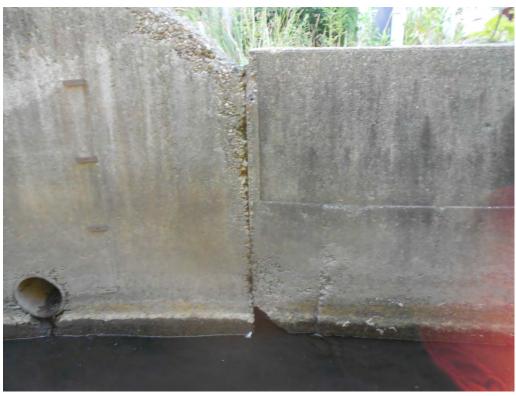
- There is severe bowing in the wall between the 3rd and 4th outlets from the south, apparently from form deflection during construction. There is a cold joint with spalling and honeycombing at the north end of the bowing.

Honeycombing and spalling along cold joint in wall

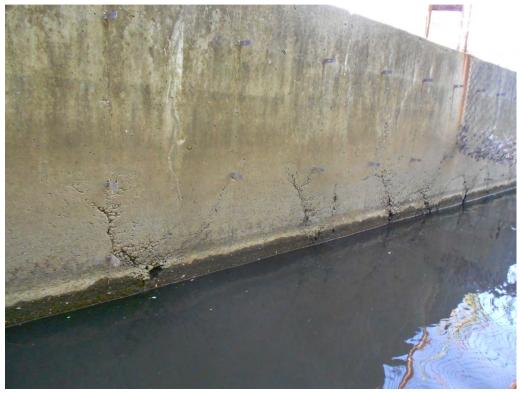
Honeycombing in face of wall

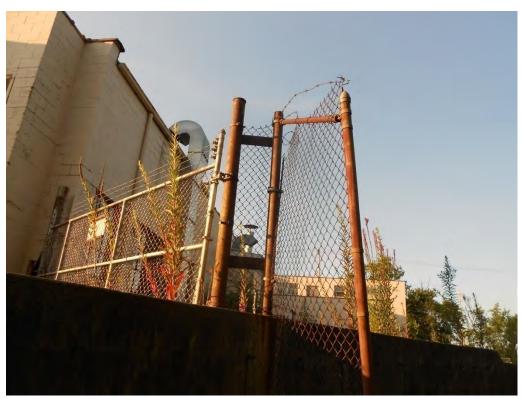
- Corrosion was noted on post and fabric members.
- The fabric is warped and failed in several locations.

Loose fabric and barbed wire on top of fence

• Remove and replace the fence in kind if required.

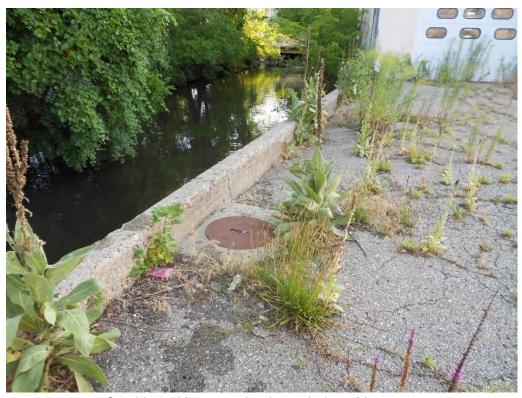
Cracking with vegetation in asphalt parking area

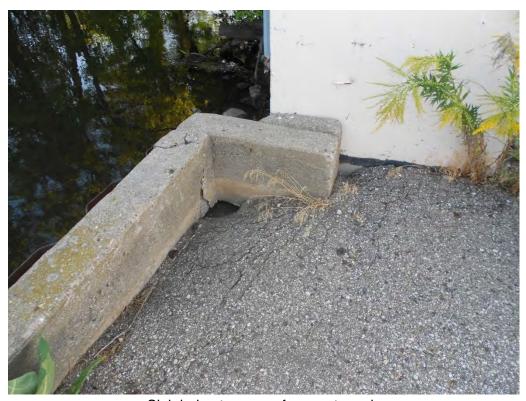
Sink hole at corner of concrete curb

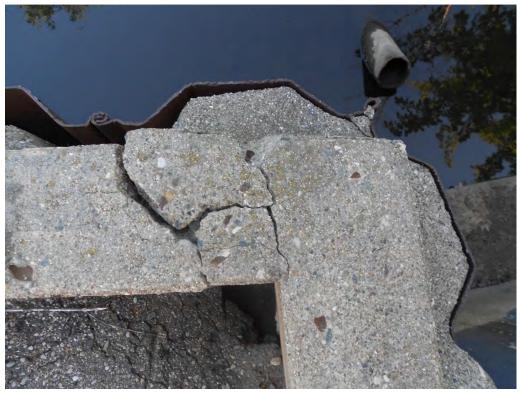
Severe cracking in concrete curb at north end of wall

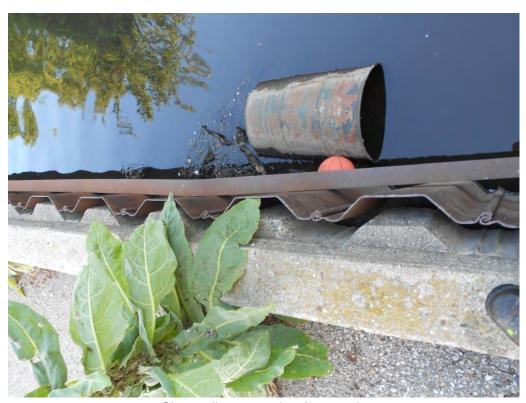
Sheet pile separation from curb

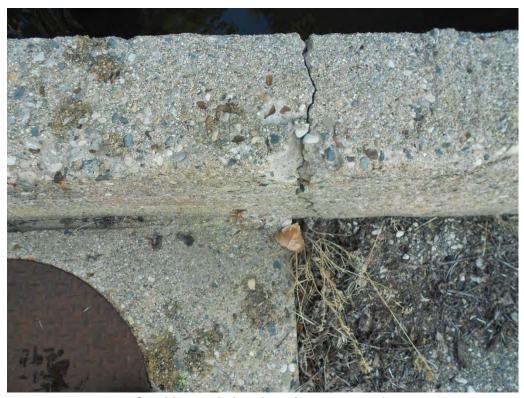
Cracking and abrasion of concrete curb

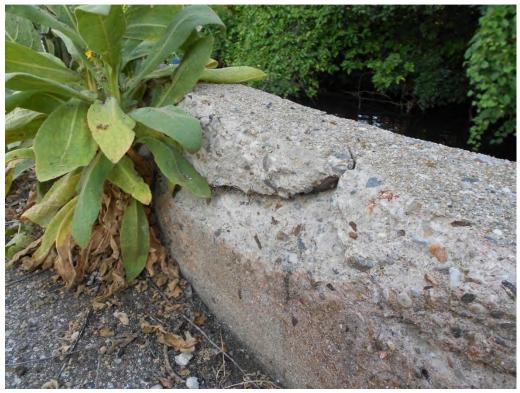
Cracking and abrasion of concrete curb

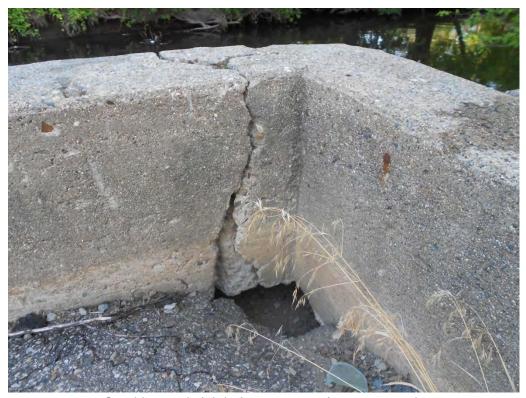
Cracking and sink hole at corner of concrete curb

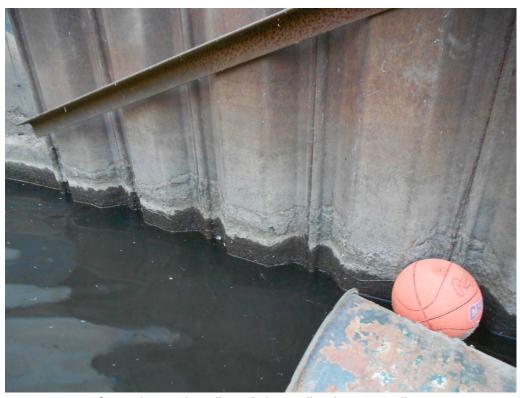
• The sheet pile has moderate corrosion and scale at the waterline, minor elsewhere.

Corrosion and scaling of sheet pile along waterline

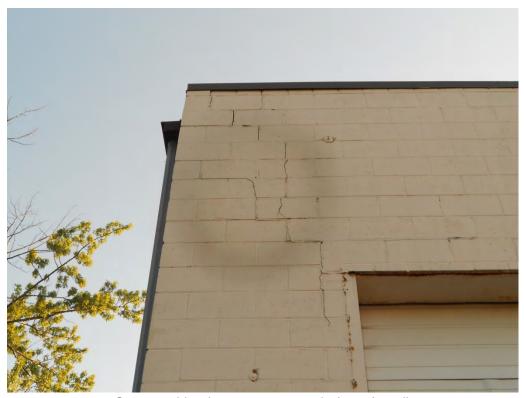
• Moderate step cracking was noted in the upper southwest corner of the building. Step cracking is typical around the overhead doors.

Step cracking in upper west end of south wall

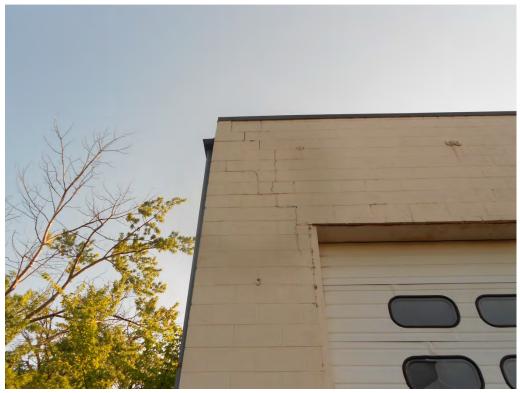
Step cracking in upper west end of south wall

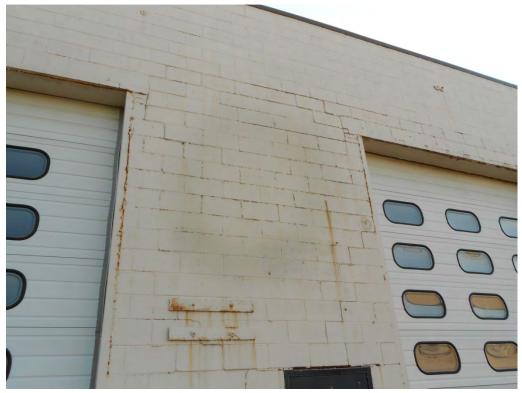
Step cracking in south wall around overhead doors

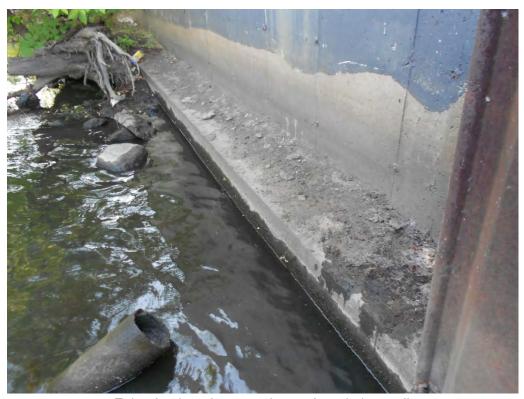
- There are several downspouts along the west wall with corrosion.
- There is an apparent false footing exposed in the southwest corner. The concrete foundation wall appears to extend below the false footing. The false footing is 12" thick extending ~17" from the face of foundation wall. The false footing is undermined, with the channel ~20" below the top of footing at the lowest spot.

False footing along southwest foundation wall

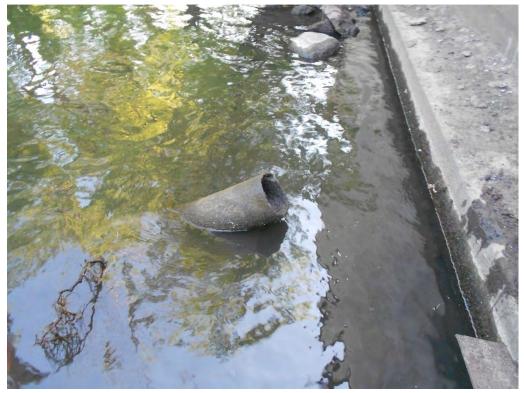
Tipped bollard in channel near southwest building corner

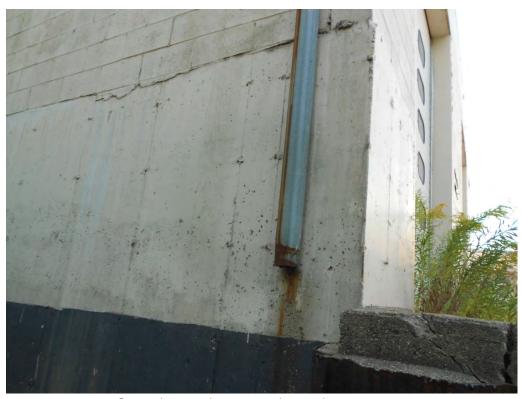
Corrosion on downspout in southwest corner

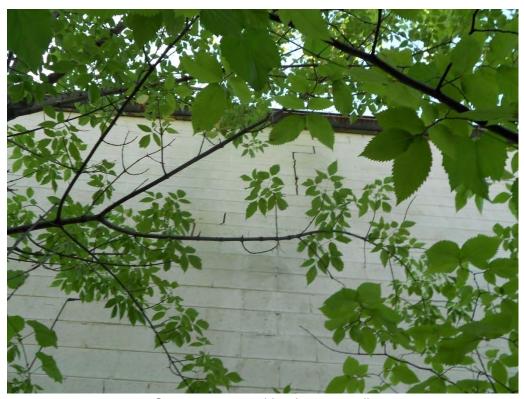
- Heavy tree and brush growth was noted along the building where the bank is intact.
- There is severe step cracking in the west wall. The south half of the west wall is partially
 obscured by trees. The cracking appears to be approximately 1" wide and extends into the
 concrete foundation wall.

Severe step cracking in west wall

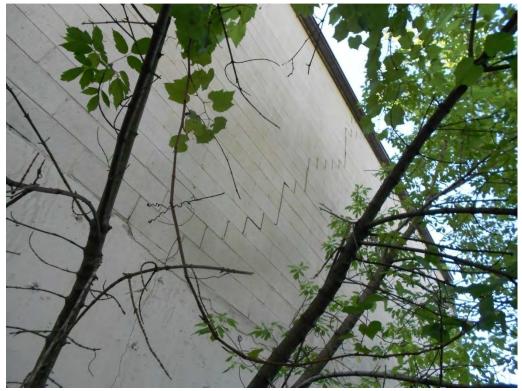
Severe step cracking in west wall

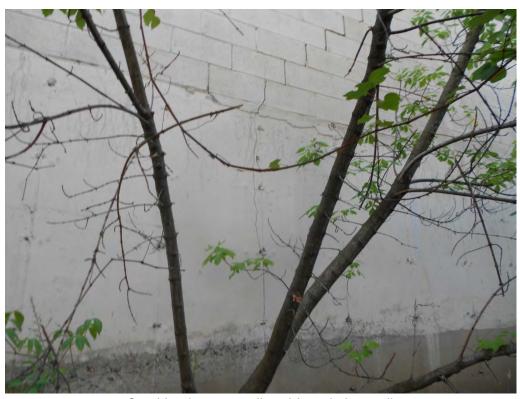
Cracking in west wall and foundation wall

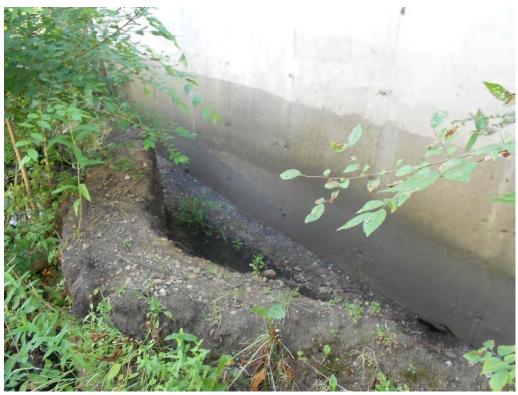
Bank failure along west wall
